Case Study: Water Quality in Lake Albert

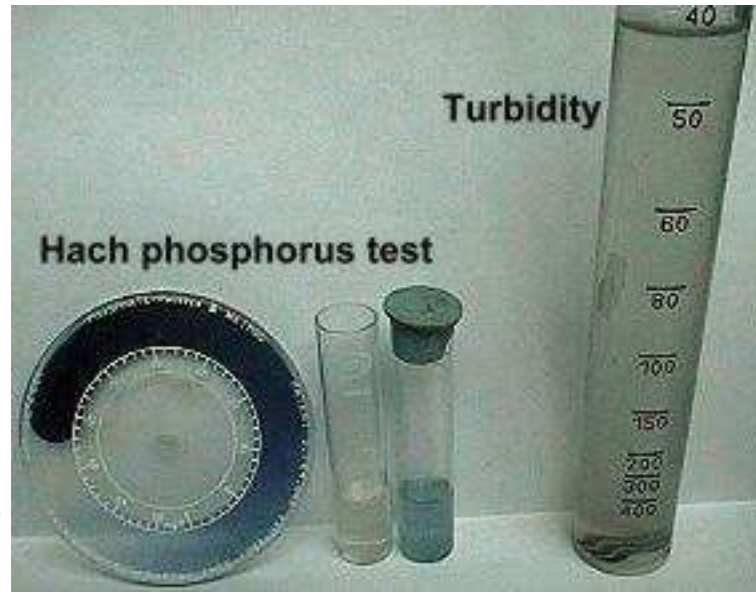
The Hach phosphorus test has two test tubes of lake water, one with a chemical added which turns any phosphorus present blue. This is then compared to a colour wheel to determine the amount of phosphorus, in this case 1.2 mg/L. This is a problem because levels above 0.05 mg/L can cause the nuisance growth of algae and the lake has been closed to recreational use on occasions due to blue-green algae.

Turbidity (muddiness caused by suspended solids such as clay particles) is measured by pouring water down the turbidity tube until the black lines on the base cannot be seen. The lake water sampled here has a turbidity level of 43 NTU's which is fairly muddy, although the Lake has had levels as high as 200 NTU's after rain. Turbid water is unpleasant for recreational use, the lake's main use and the suspended clay particles causing the turbidity have phosphorous attached to them.
